NASA/TM-2003-212439  
ARL-TR-3046

# Characterization of Cracking and Crack Growth Properties of the C5A Aircraft Tie-Box Forging

*Robert S. Piascik and Stephen W. Smith  
Langley Research Center, Hampton, Virginia*

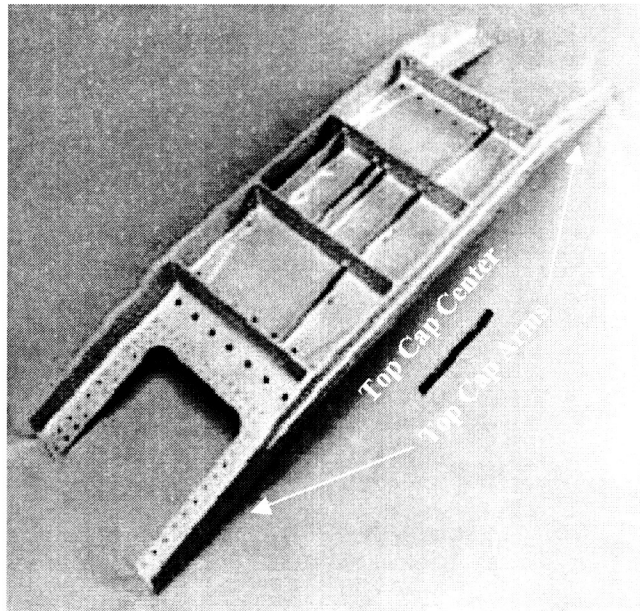
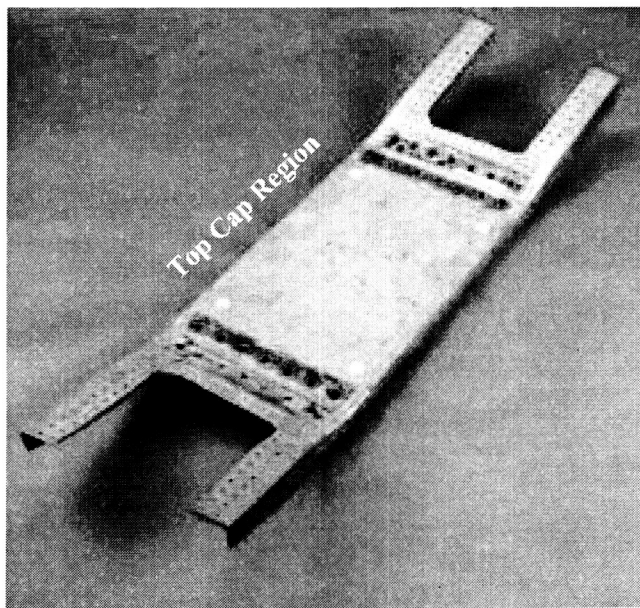
Nondestructive examinations (visual and eddy current) of the C5A horizontal stabilizer tie box forging shown in Figure 1 indicated the presence of through-the-thickness cracks emanating from fastener holes along the top and bottom cap regions. The subsequent inspection of a C5B aircraft conducted by the USAF revealed no evidence of cracking. Although both C5A and C5B tie box forgings are constructed of 7075T6 aluminum having the same nominal composition (1.6% Cu – 2.5% Mg – 5.6% Zn – 0.23% Cr, compositions in weight percent [1]), it was thought that differences in thermo-mechanical processing may have produced differences between the C5A and C5B material properties. A C5A and C5B tie box forging were sent from Robins AFB to NASA Langley Research Center for detailed destructive examination. The objective of this work was to:

Figure 1. The photographs show the general features of the C5A tie box forging.

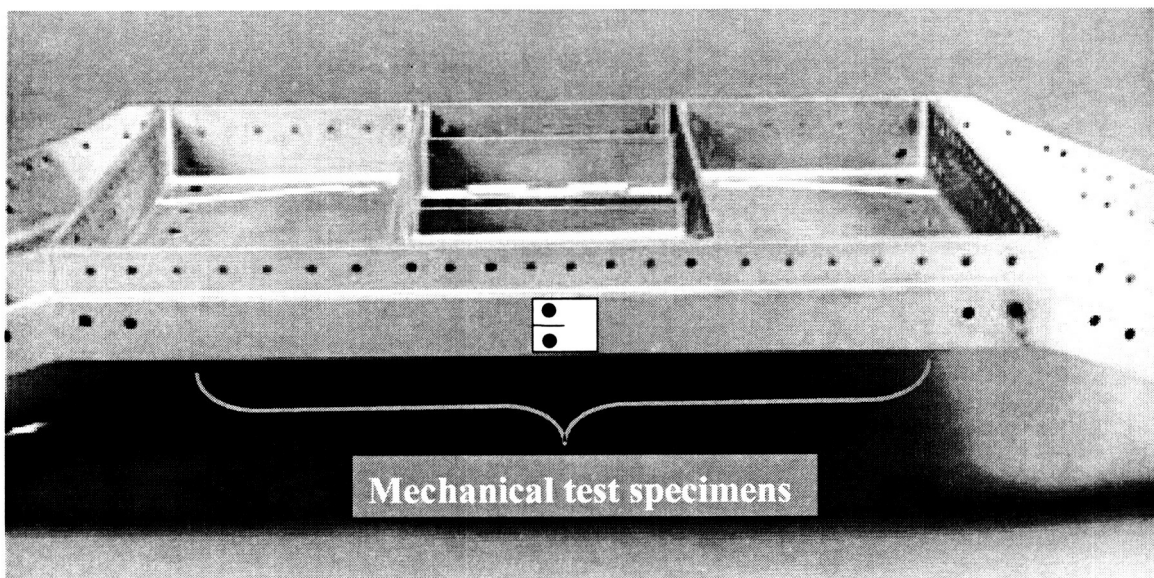
Figure 2. The photograph shows the C5A forging top cap center region. Fracture toughness and stress corrosion specimens were machined from the cap region for the C5A and C5B forging.

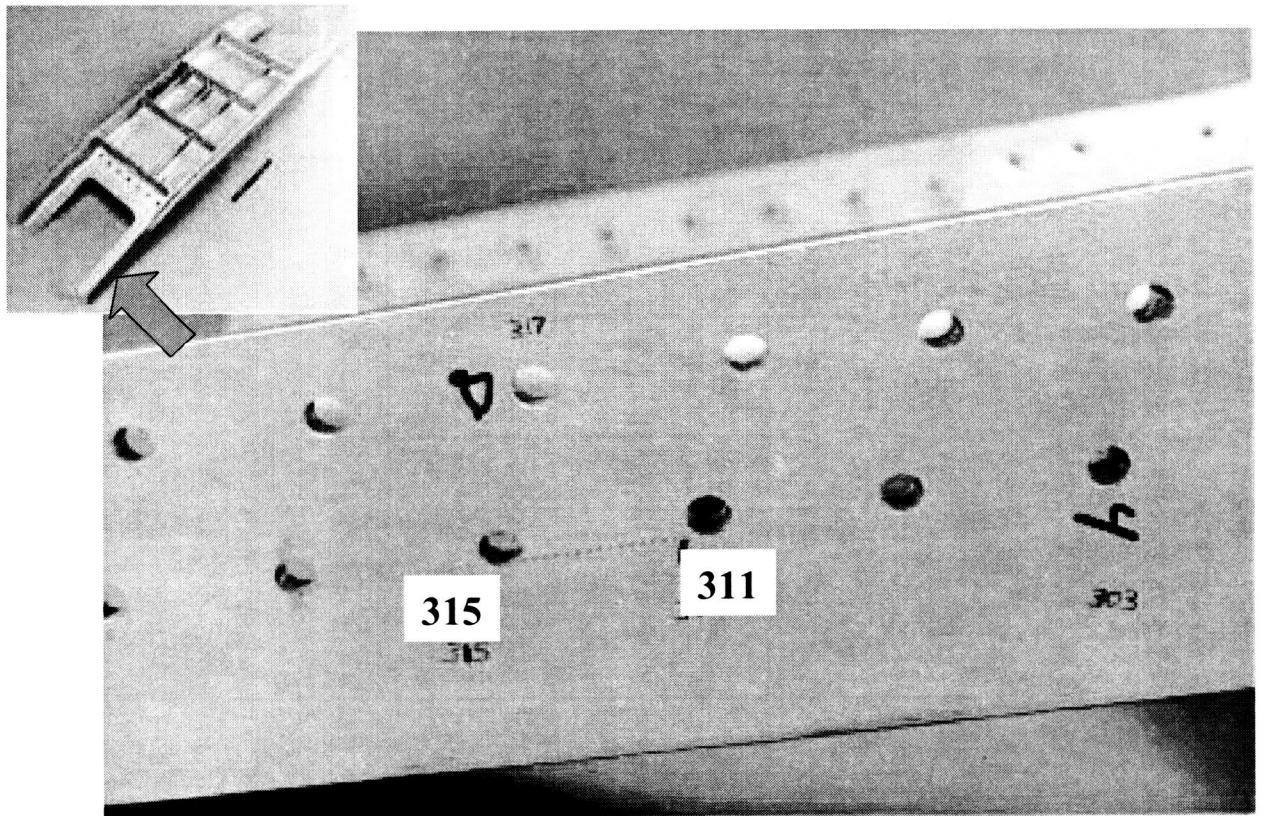
Figure 4. The large photograph shows the outside surface top cap arm region of the C5A tie-box (the region is identified by the arrow in the small photograph). A dashed line identifies the location of the crack between fastener holes #311 and #315.

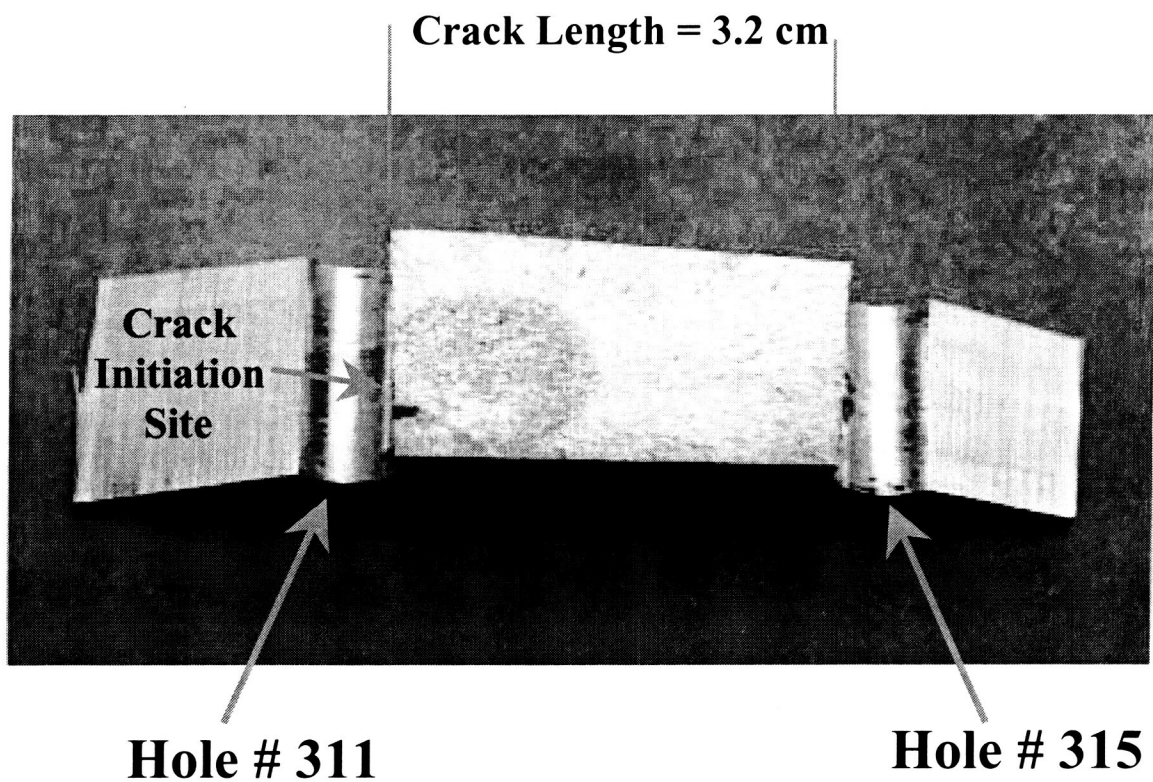
Figure 5. The photograph shows the surface of the crack emanating from hole #311 and propagating to hole #315.

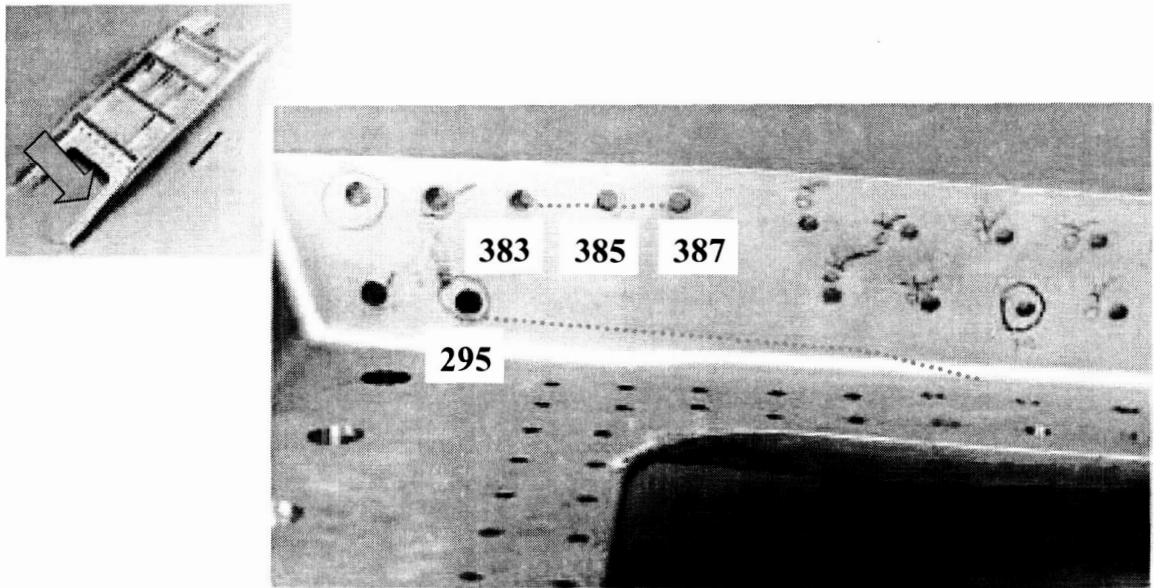
Figure 6. The large photograph shows the inside surface of the top cap arm region of the C5A tie-box (the region is identified by the arrow in the small photograph). Dashed lines identify the cracks at fastener holes #383, #385, #387 and #295.

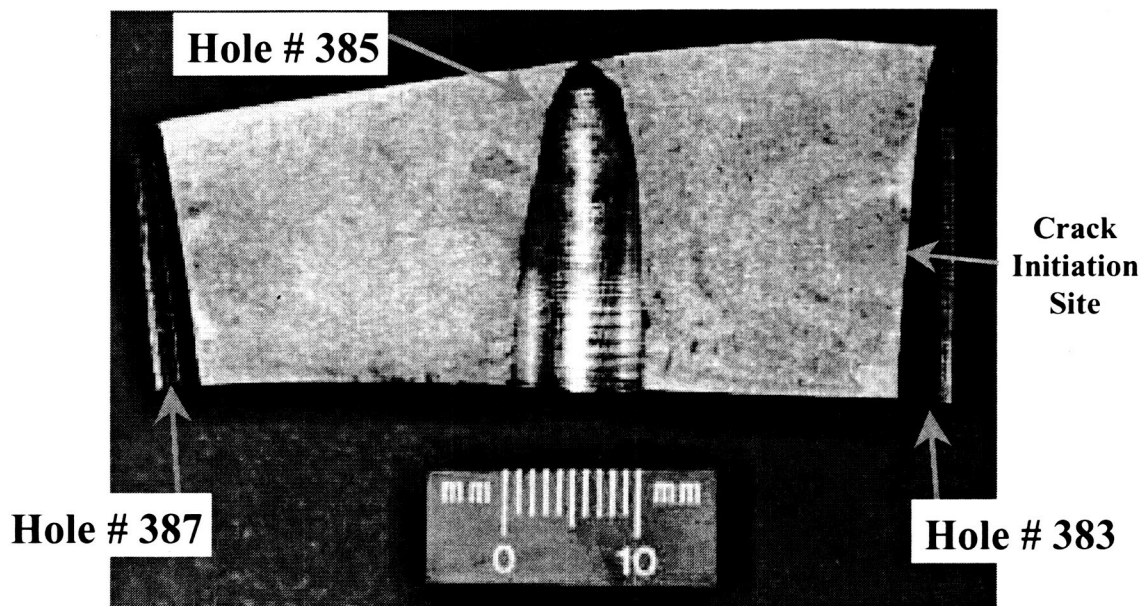
Figure 7. The photograph shows the surface of the crack that initiated from fastener hole #383 and terminating at hole #387.

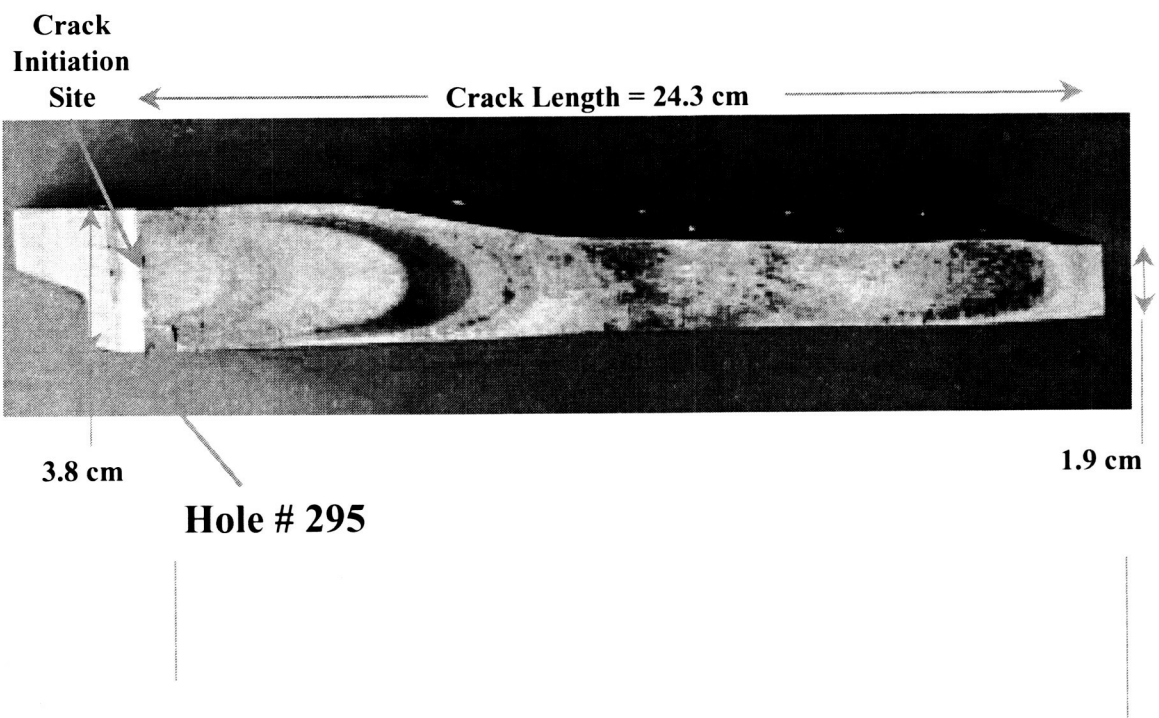
Figure 8. The photograph shows the surface of the crack emanating from fastener hole #295.

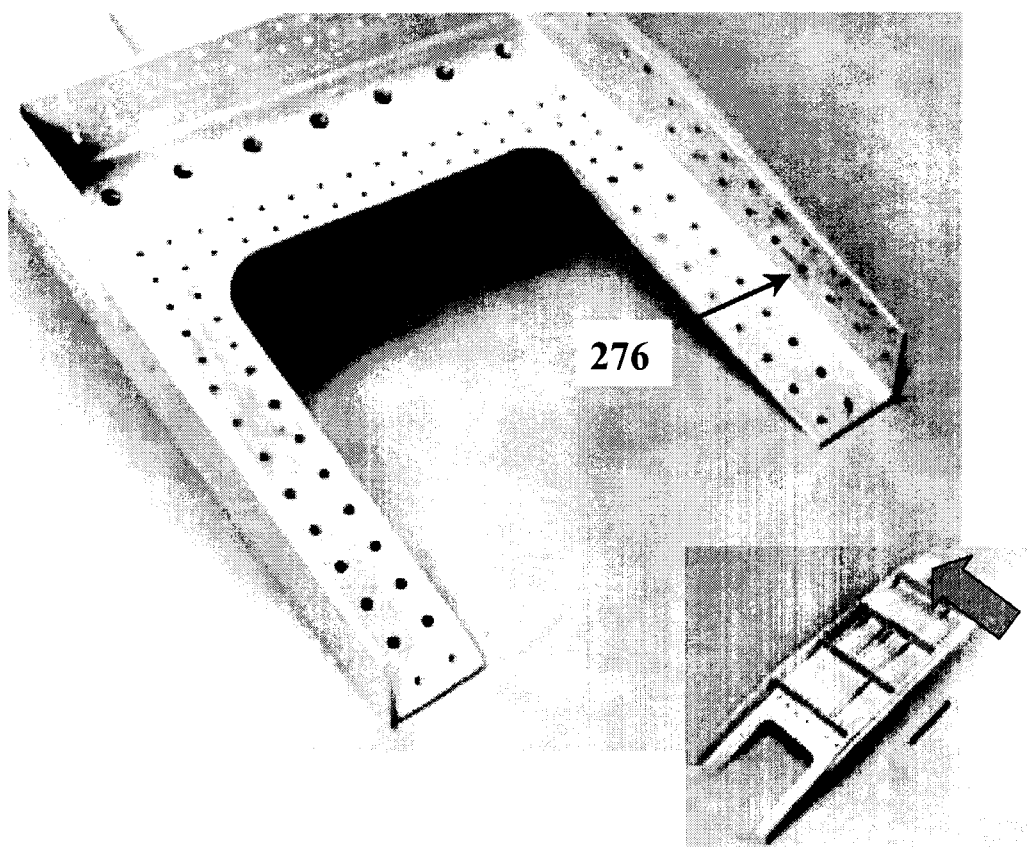
Figure 9 shows the location and orientation of the crack that initiated at fastener hole #276 in the tie-box lower cap arm. Figure 10 shows the surface of the crack; here, two halves (metallographic sections) of the specimen were placed together so the complete crack surface could be viewed. The crack initiated in the interior of fastener hole #276. The dashed line marks the curved crack front. The discolored regions on the crack surface are areas of heavy corrosion products. The crack initially propagated in a tunneled crack front configuration and first penetrated one surface (upper side surface in Figure 10) and later penetrated the other side surface thus forming the final curved crack front. Prior to opening the crack and examining the crack surface shown in Figure 10, a metallographic cross-section was performed normal to the crack to determine the microstructural crack path (this is the reason why two pieces are present in Figure 10). Figure 11a shows the location of the crack and the surrounding etched grain structure. Figures 11b and 11c show portions of the crack at higher magnification. Figure 11b shows that the cracking is intergranular and some regions exhibit extensive intergranular crack branching. Figure 11c shows the crack-tip region located on or very near a grain boundary.

Figure 9. The large photograph shows the inside surface of the lower cap arm region of the C5A tie-box (the region is identified by the arrow in the small photograph). The line identifies the location of the crack at fastener hole #276.

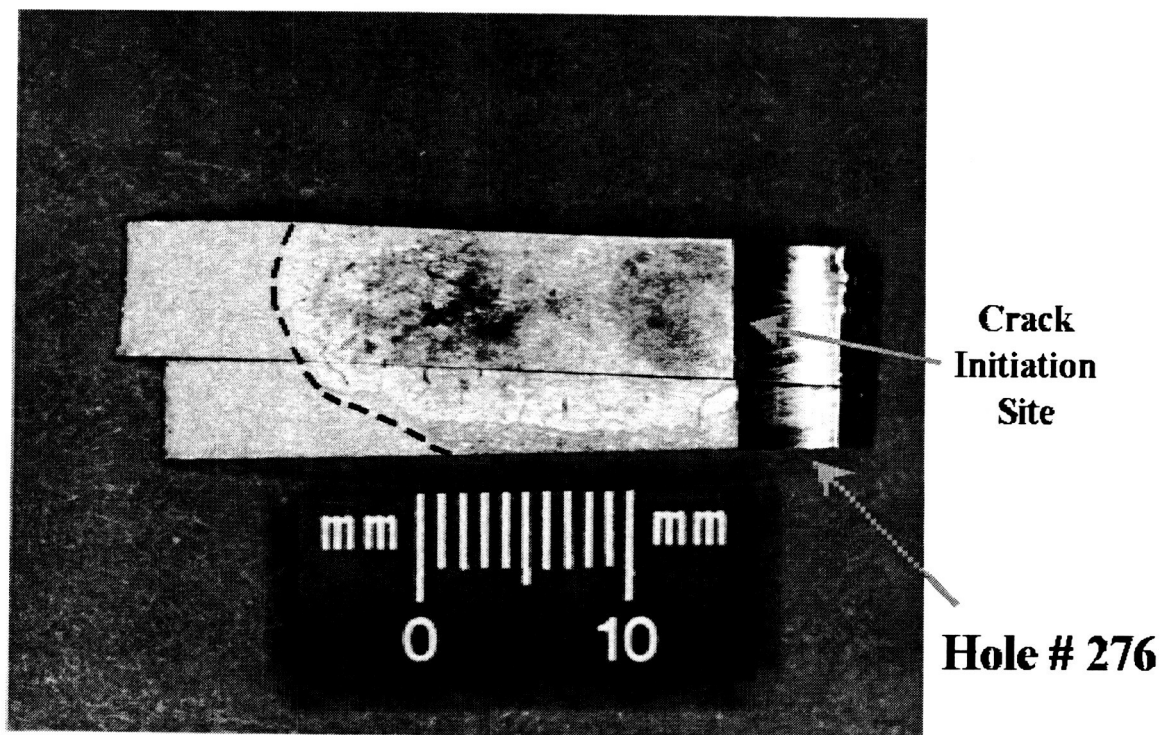
Figure 10. The photograph shows the surface of the crack that initiated at fastener hole #276.

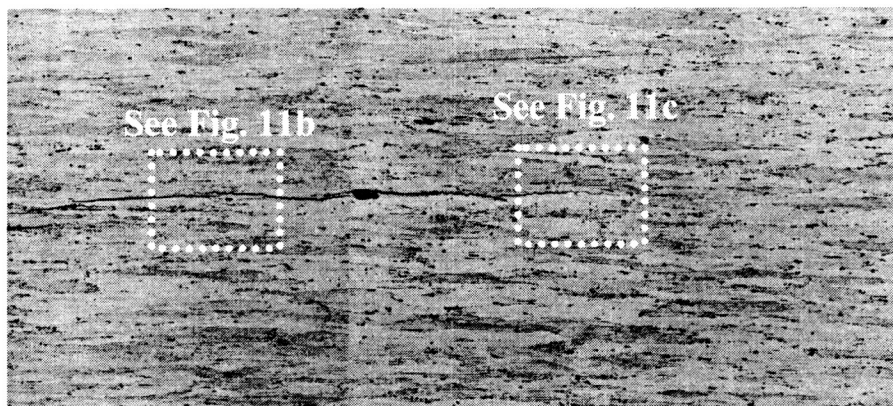
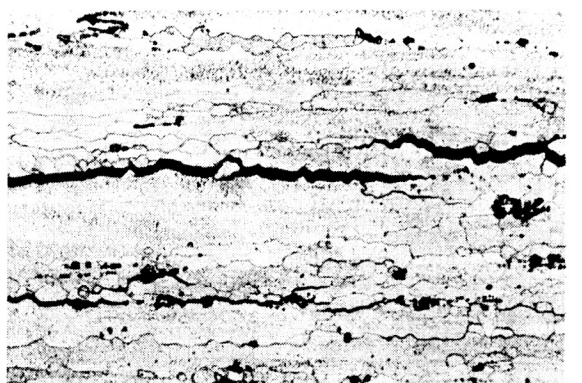
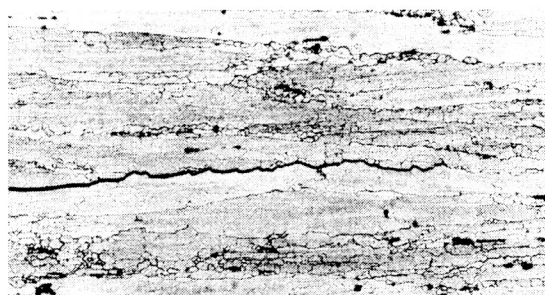
Figure 11. Shown are optical micrographs of the crack emanating from fastener hole #276. The location of Figures 11b and 11c are identified (square regions) in Figure 11a.

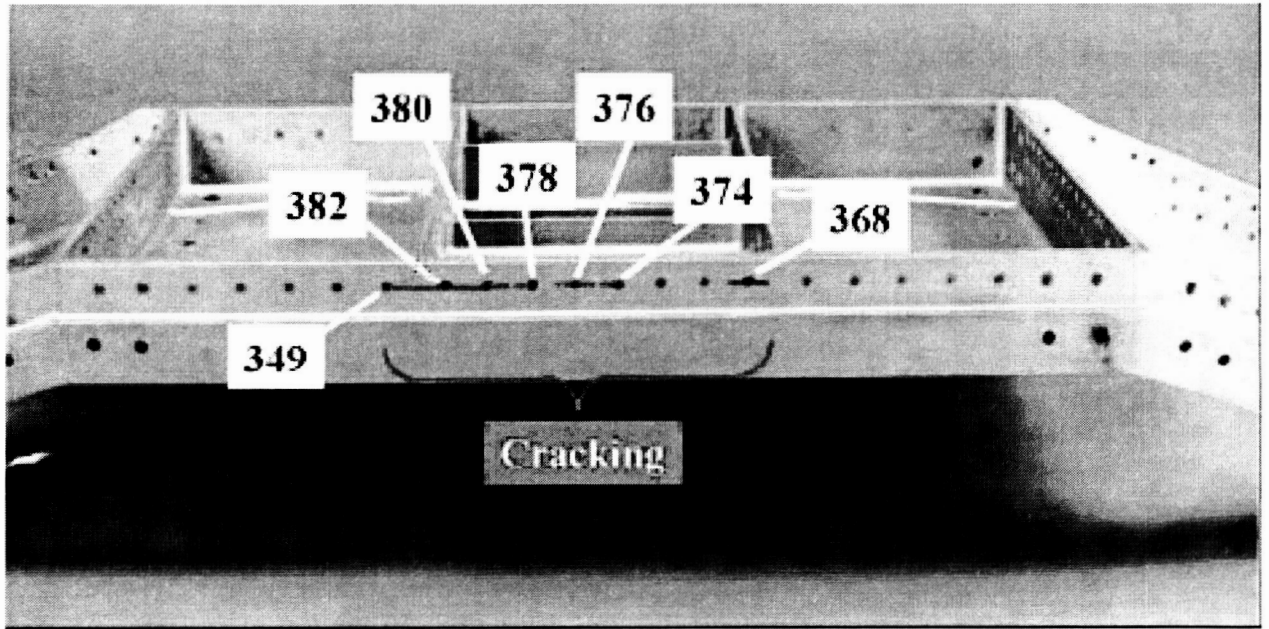
Figure 12 shows the location of cracks found in the C5A forging top cap center region. Cracks were observed in fastener holes #349, #382, #380, #378, #376, #374 and #368. Figure 13 shows the surface of the crack that initiated at the mid-thickness region in fastener hole #382. The crack grew approximately 50 mm (2 inch) into a forging web and also terminated in fastener hole #349. The discolored regions on the crack surface are areas of heavy corrosion products. Figure 14 shows the conjugate surfaces of the crack that initiated on the opposite side of hole #382 near the mid-thickness region. The crack surface exhibits discoloration (corrosion products) along the edges (side surface regions) of the crack. Figure 15 shows the conjugate surfaces of the cracks that propagated between fastener holes #378 and #380. Here, the crack surface exhibits regions of distinct elevation change suggesting the initiation and growth of multiple cracks and crack coalescence. Because of the rather featureless crack surface, the site(s) of crack initiation were not identified. Figure 16 shows the conjugate surfaces of the crack that initiated at the mid-thickness of fastener hole #378. The dashed line marks the location of the curved final crack front. Figure 17 shows the conjugate surfaces of the crack that initiated at the mid-thickness of fastener hole #376. The dashed line marks the location of the curved final crack front. Regions of corrosion products (discoloration) are located near the final crack front. Figure 18 shows the conjugate surfaces of the crack that initiated at the mid-thickness of fastener hole #374. The dashed lines mark the location of the crack front; a portion of the crack front was unintentionally cut off during removal of the crack from the forging. Figure 19 shows the mating surfaces of the crack that initiated at fastener hole #368. The crack front region was cut off during removal of the specimen from the forging. The ridge along the middle of the crack surface suggests that two cracks nucleated and coalesced forming the ridge. The crack surface exhibits few features that could be used to identify the region of crack initiation in fastener hole #368. Figure 20 shows the crack that initiated from the opposite surface of fastener hole #368. The crack front region was cut off during removal of the specimen from the forging. The crack surface exhibits few features of interest.

Figure 12. The photograph of C5A tie-box forging shows the location of cracking (red solid and dashed lines) in the top cap center region (fastener holes #349, #382, #380, #378, #376, #374 and #368).

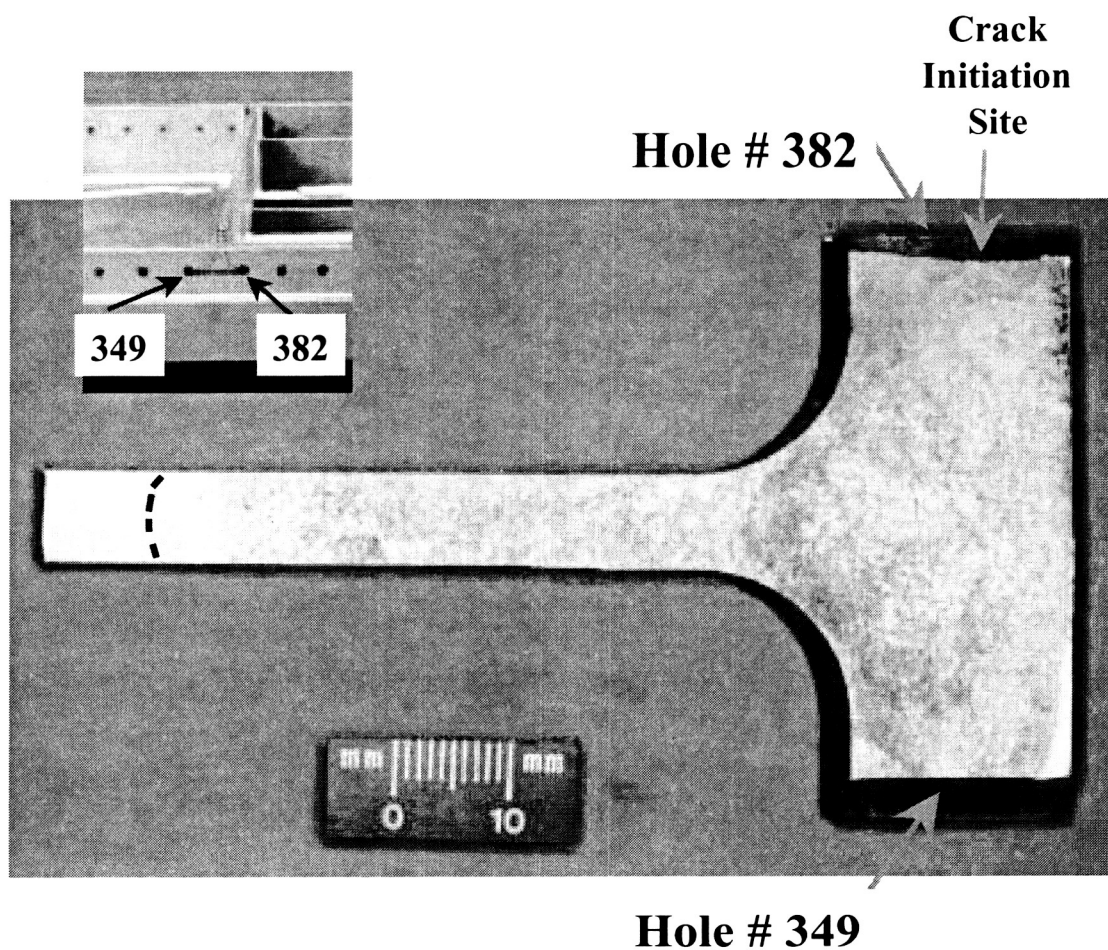
Figure 13. The photograph shows the surface of the crack emanating from fastener hole #382 and propagating into hole #349 and the forging web. The location of fastener holes #349 and #382 is shown in the small photograph. The dashed line shows the final crack front in the forging web.

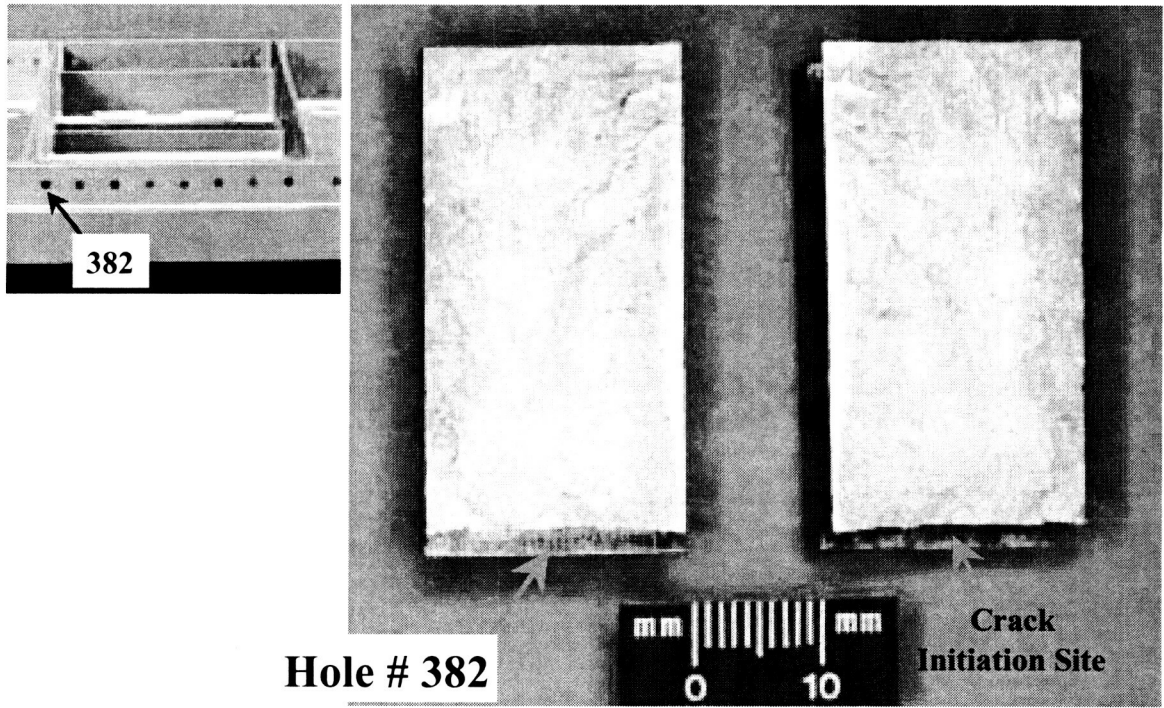
Figure 14. The photograph shows both surfaces of the crack emanating from fastener hole #382. The location of fastener hole # 382 is shown in the small photograph.

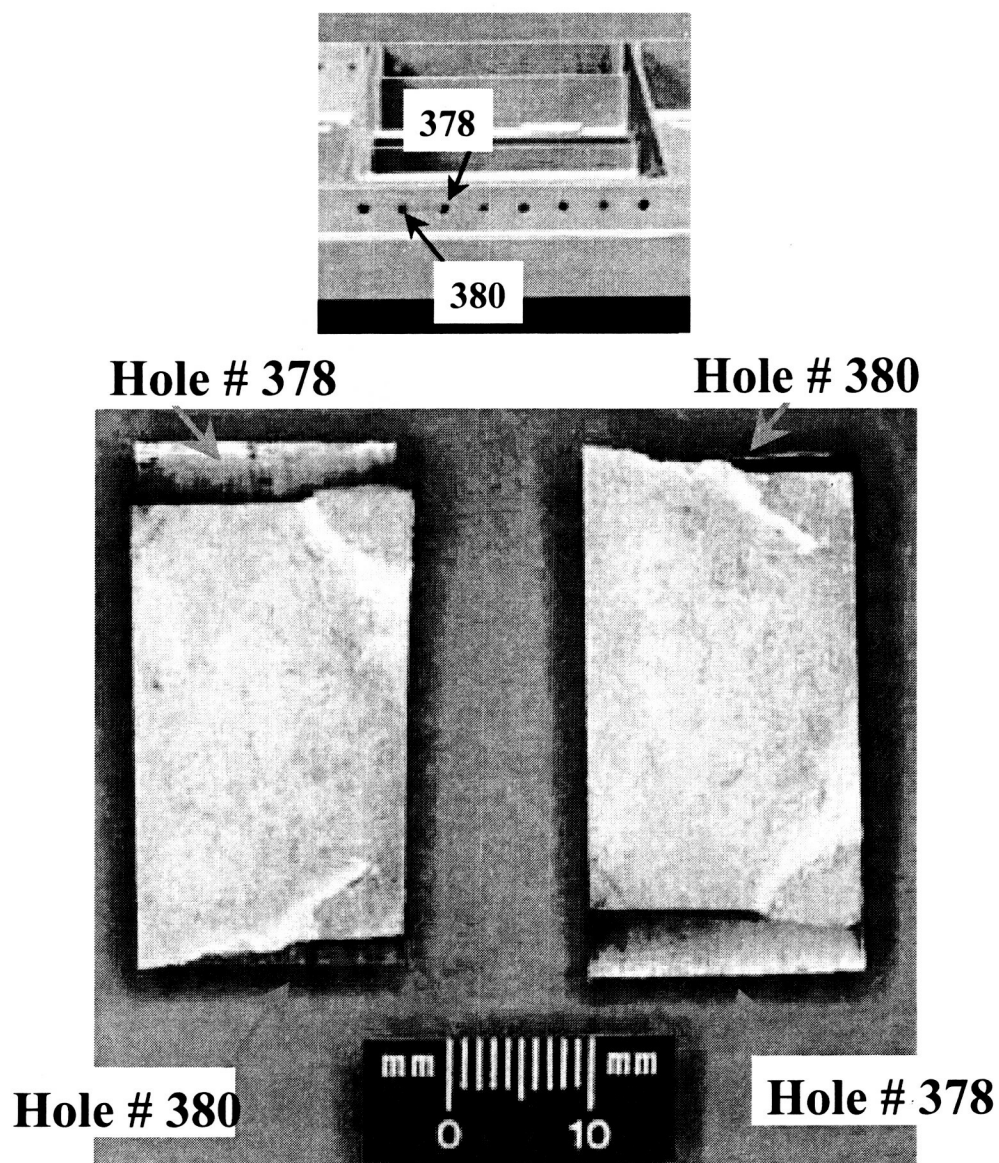
Figure 15. The photograph shows both surfaces of the crack located between fastener holes #380 and #378. The location of fastener holes #380 and #378 is shown in the small photograph.

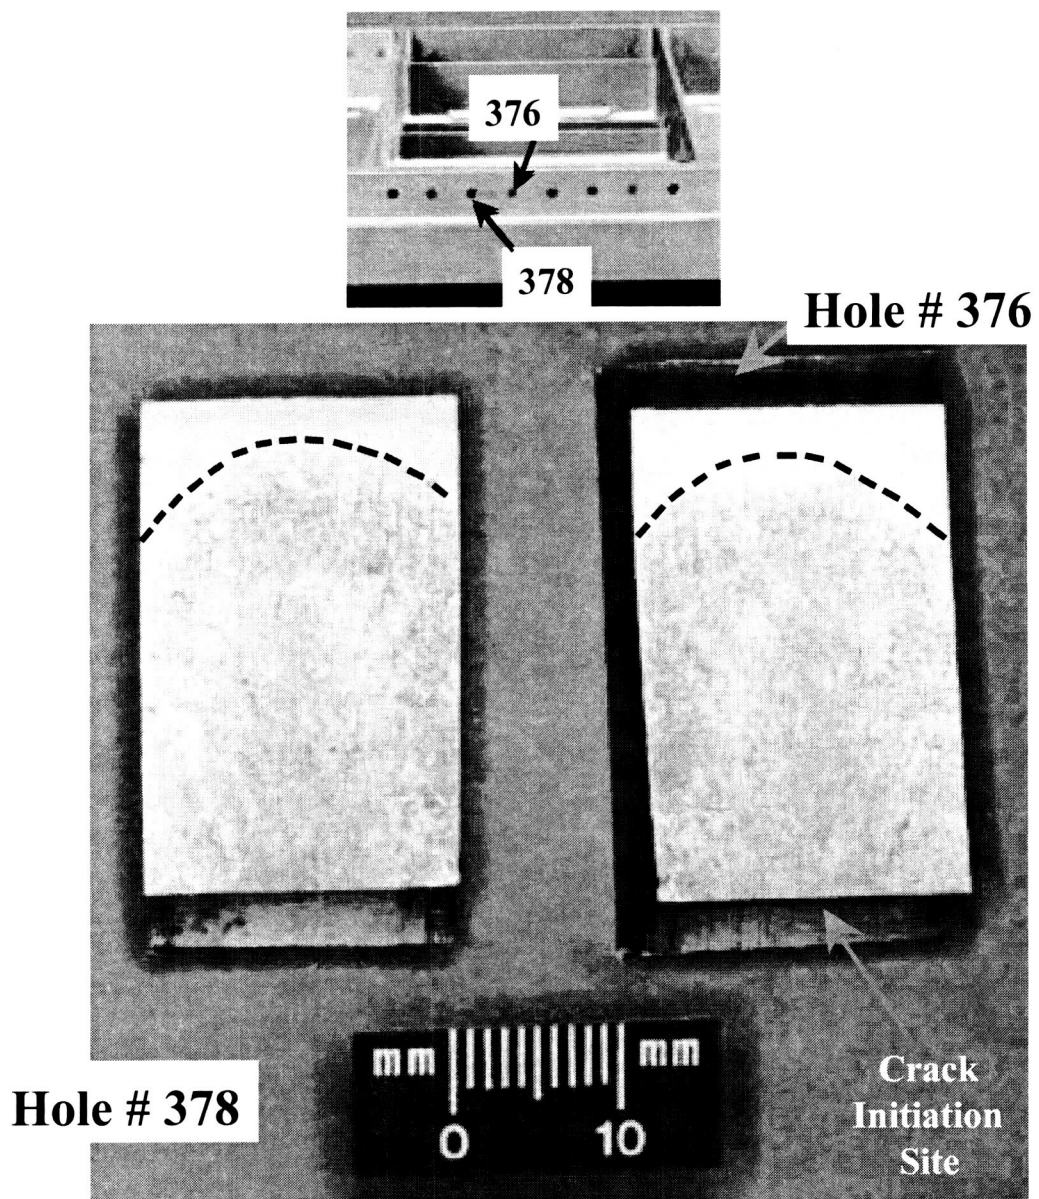
Figure 16. The photograph shows both surfaces of the crack emanating from fastener hole #378. The location of fastener holes #378 and #376 is shown in the small photograph.

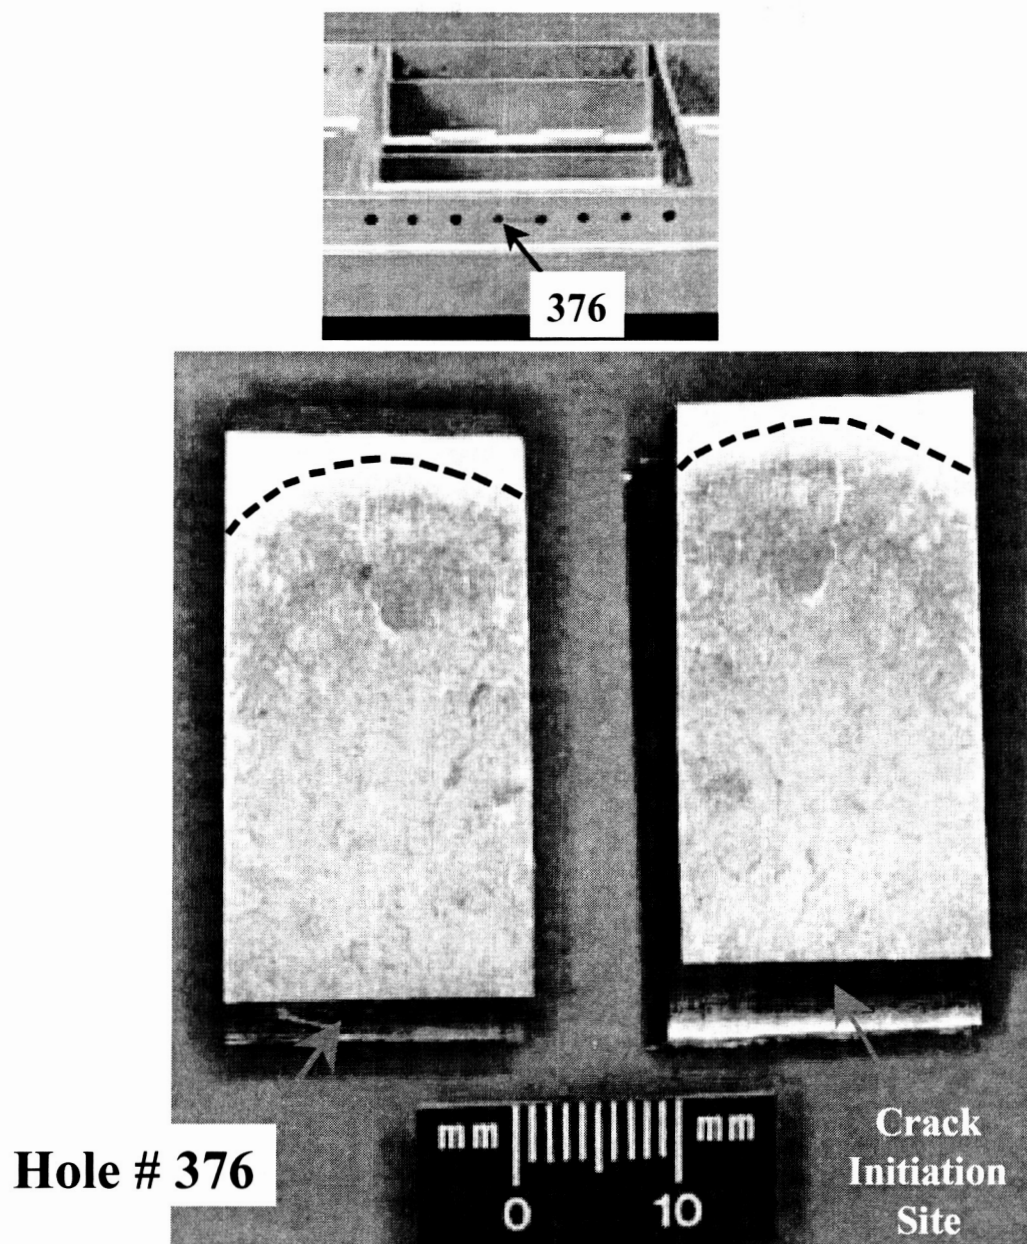
Figure 17. The photograph shows both surfaces of the crack emanating from fastener hole #376. The location of fastener hole #376 is shown in the small photograph.

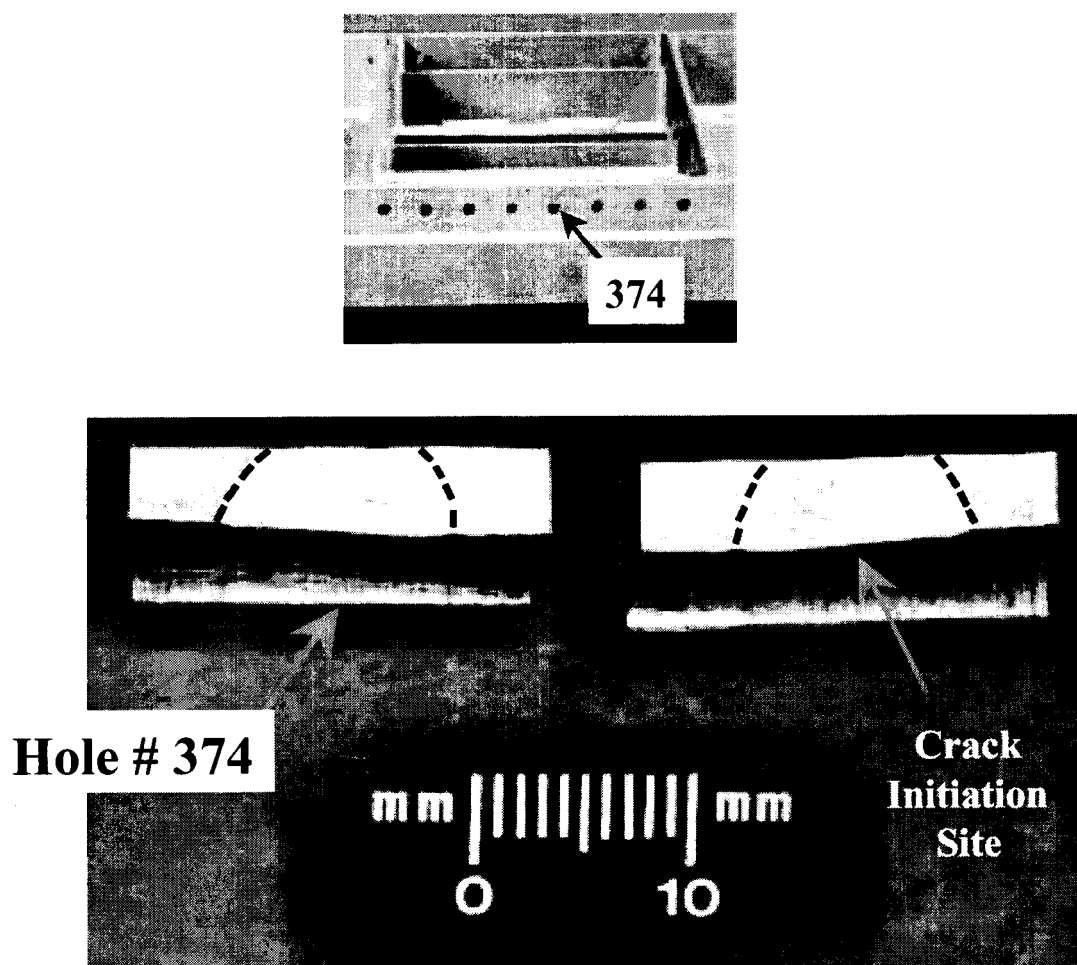
Figure 18. The photograph shows both surface of the crack emanating from fastener hole #374. The location of fastener hole #374 is shown in the small photograph.

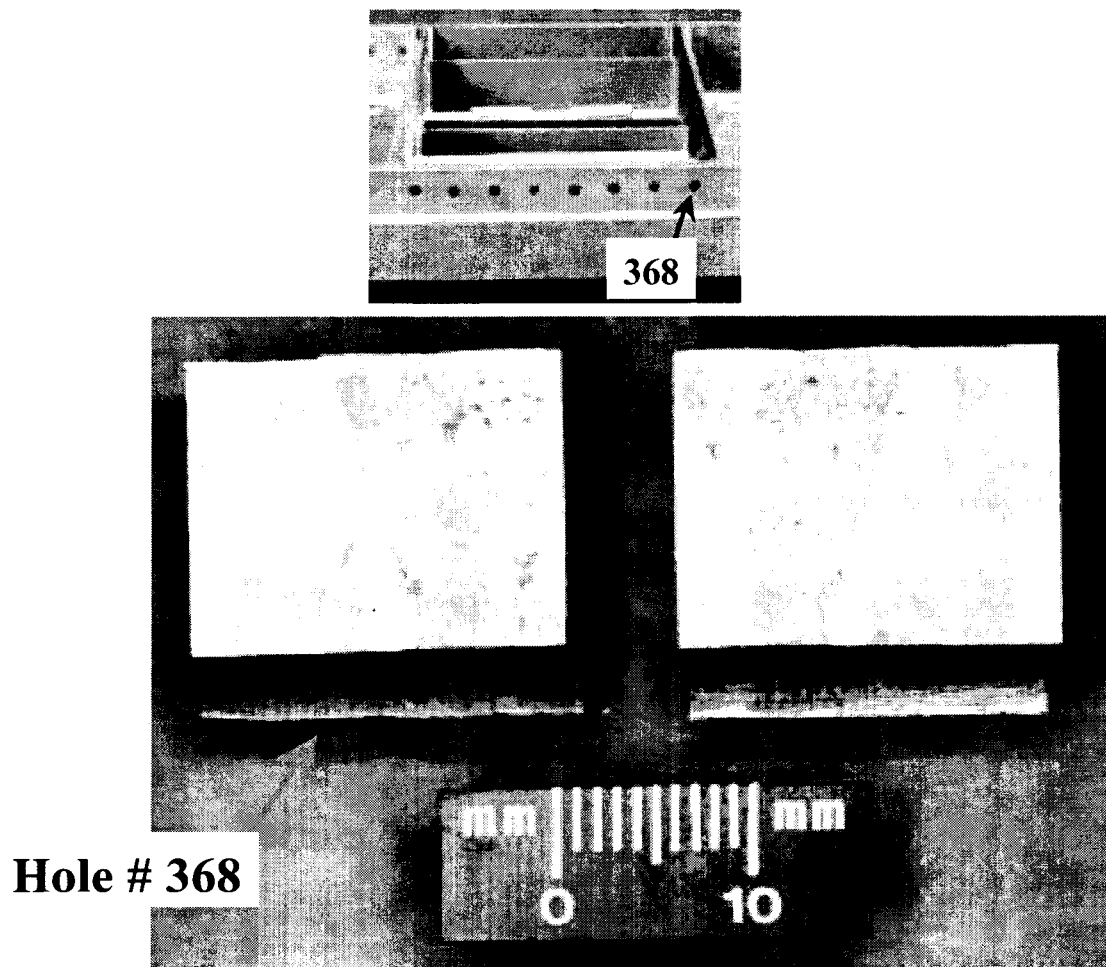
Figure 19. The photograph shows both surfaces of the crack emanating from fastener hole #368. The location of fastener hole #368 is shown in the small photograph.

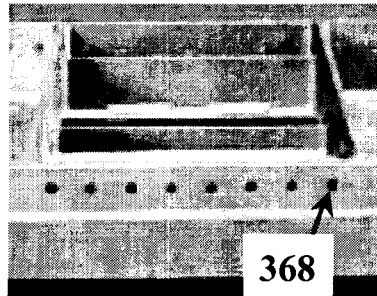
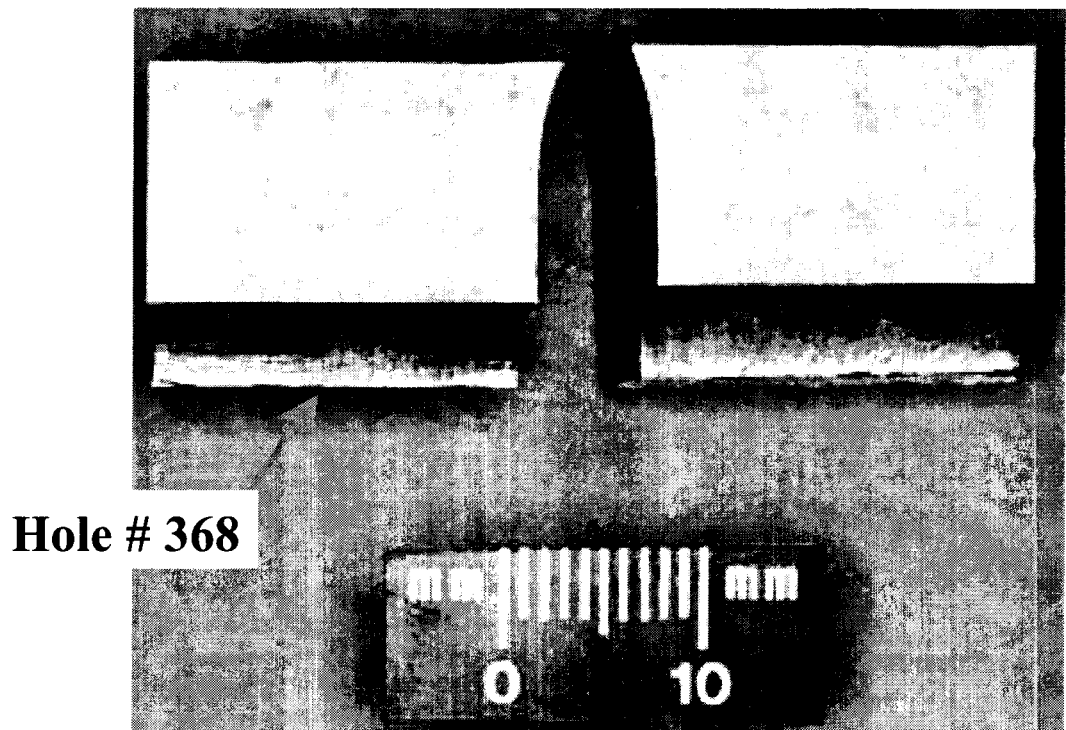
Figure 20. The photograph shows both surfaces of the crack emanating from fastener hole #368. The location of fastener hole #368 is shown in the small photograph.

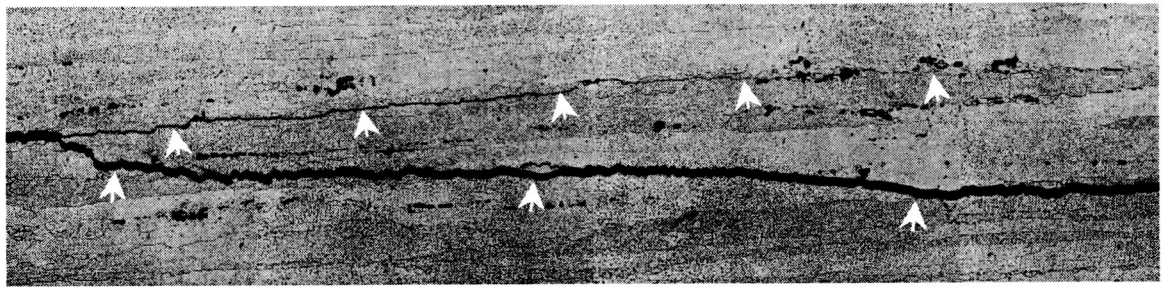
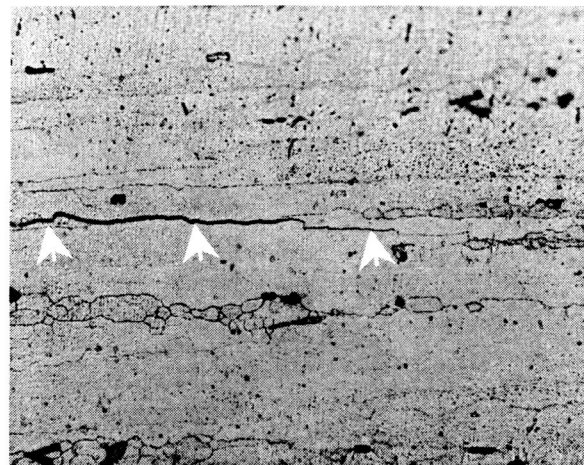
Optical microscopy was conducted on the specimens after fatigue crack growth testing. The side surface of the FCG specimen tested at a  $K_{max} = 6.6 \text{ MPa}\sqrt{\text{m}}$  was polished and etched prior to FCG testing so that the path of the fatigue crack could be tracked relative to the microstructure. Figure 22a shows that the path of both the main crack and crack branching (upper arrows) are intergranular. Figure 22b shows the fatigue crack-tip region and reveals that the crack-tip is located along a grain boundary. These result show that the crack paths of fatigue cracks grown in laboratory air are along grain boundaries and exhibit intergranular crack branching similar to the cracks found in the C5A forging shown in Figure 11. Detailed SEM examination of the intergranular fatigue crack surfaces at high magnification showed that the surface morphology was similar to crack surfaces removed from the tie box forging. Similar to the forging cracks, no evidence of striations was observed on the fatigue test crack surfaces.

Figure 22. Optical micrographs of an etched surface showing the intergranular fatigue crack growth crack path for FCG test conducted on C5A material. (a) The micrograph shows the main fatigue crack (lower arrows) and a secondary fatigue crack (upper arrows) that propagated along or near grain boundaries. (b) The micrograph shows the fatigue crack tip region (marked by arrows) and definitively shows that the fatigue propagated along grain boundaries.
